*SAPIEN 3 Valve Balloon Rupture During  
Transcatheter Aortic Valve Replacement*

Bailout measures to manage peri-procedural complications

*Eric Maupas*

*Hôpital Privé Franciscaines*

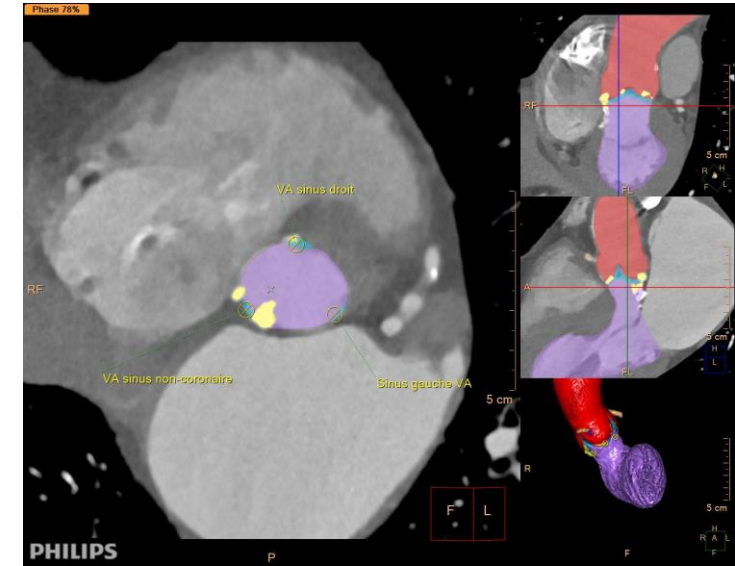
## Pre TAVI CT scan

- Tricuspid aortic valve (Scoring Ca+++ = 4892)
- Annular and LVOT protrusive calcifications
- Aortic angulation = 37°
- Annular area = 493 mm<sup>2</sup>, perimeter 79 mm
- Moderate aortic and ilio femoral axis calcifications

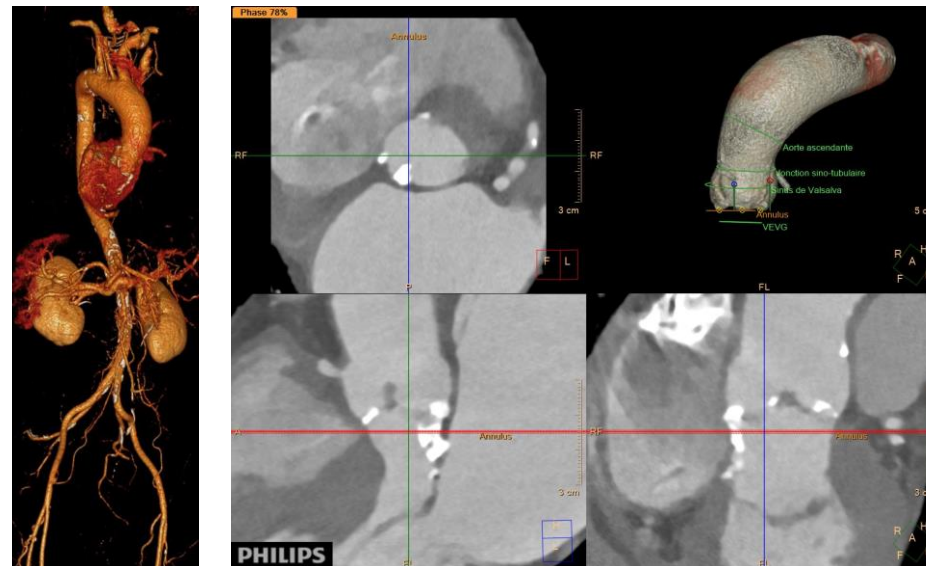
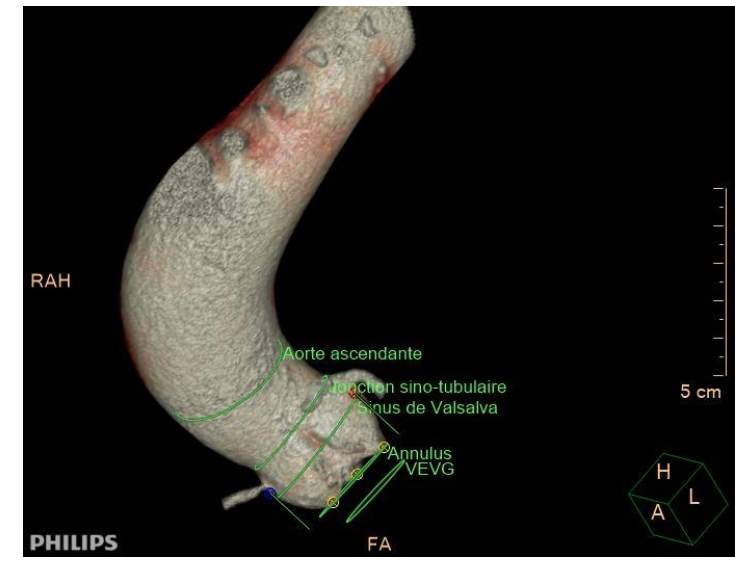
## STANDARD TAVI PROCEDURE Annular protrusive calcifications

EDWARDS S3 26 mm

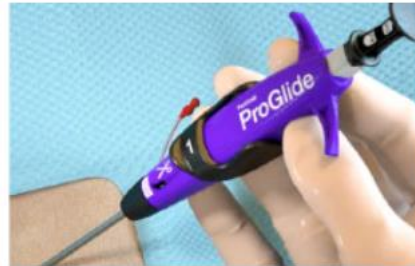
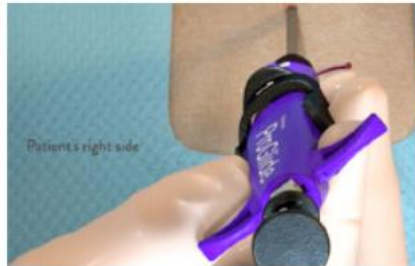
Ultrasound-guided puncture (100%)  
ANGIO before percutaneous approach

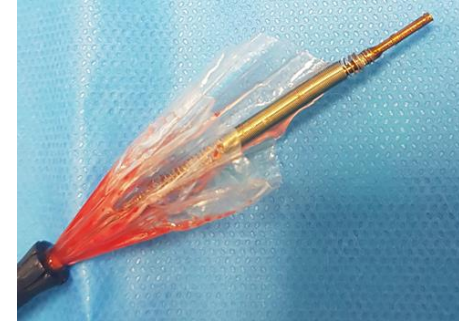
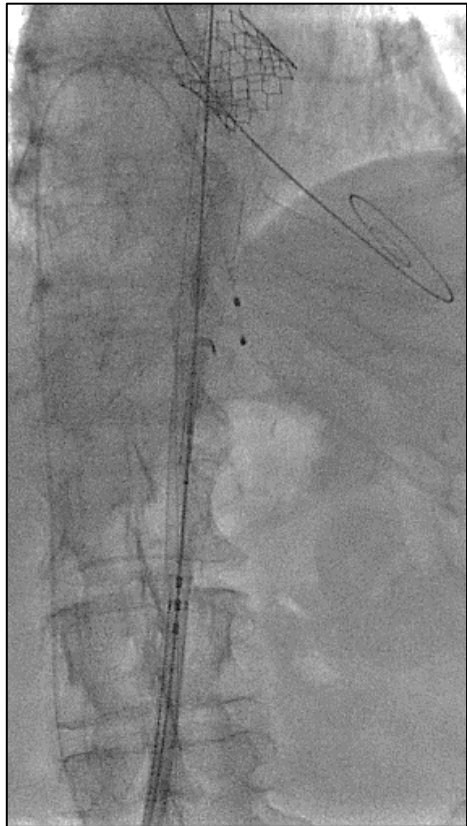
Removal of eSheath EDWARDS + Delivery System and valve balloon and as 1 unit

**but...**

The Nose Cone was stuck at the iliac level and was unable to be retrieved

The eSheath was exchanged for a larger 18F sheath (COOK)

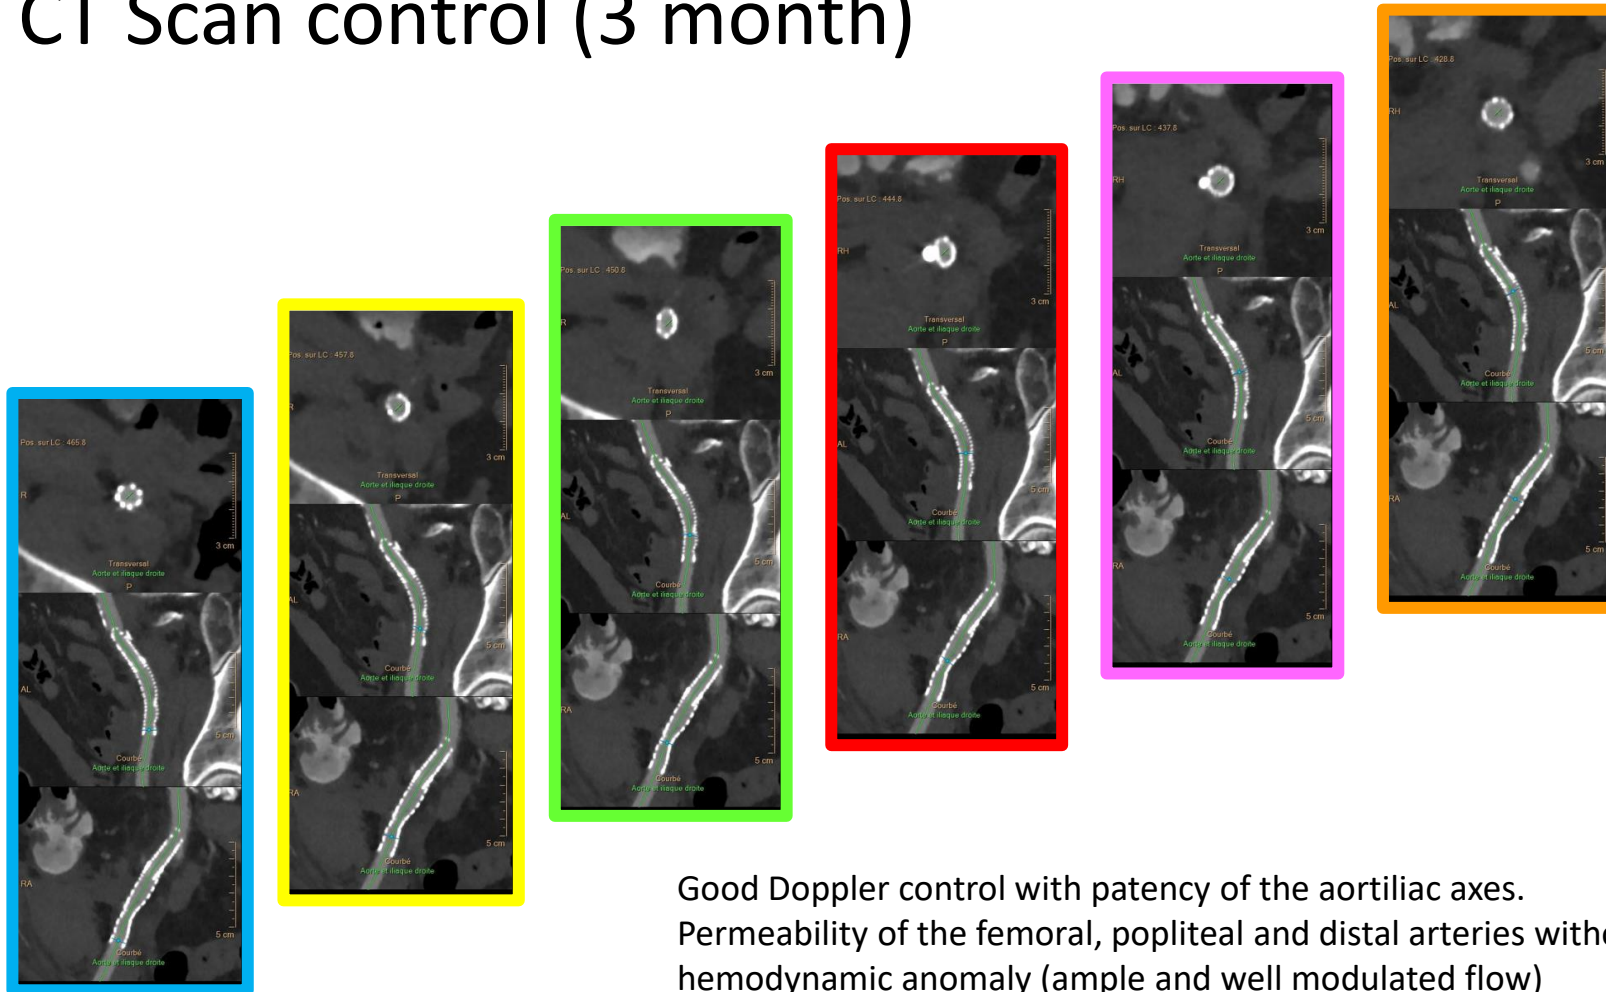
## CT Scan control (3 month)

Good Doppler control with patency of the aortiliac axes.  
Permeability of the femoral, popliteal and distal arteries without hemodynamic anomaly (ample and well modulated flow)

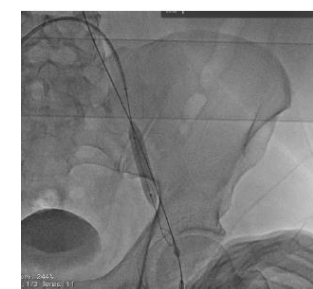
A 9 40-mm Passeo balloon (Biotronik) inflated in the left external iliac for adequate hemostasis.

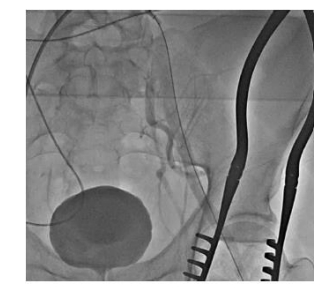
Final angiogram showing successful repair of left common femoral artery (Online Video 2).

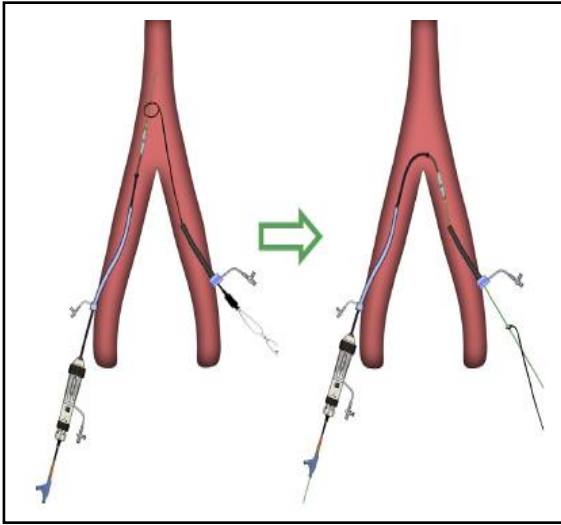
**STEP 1: snare and externalize the wire**

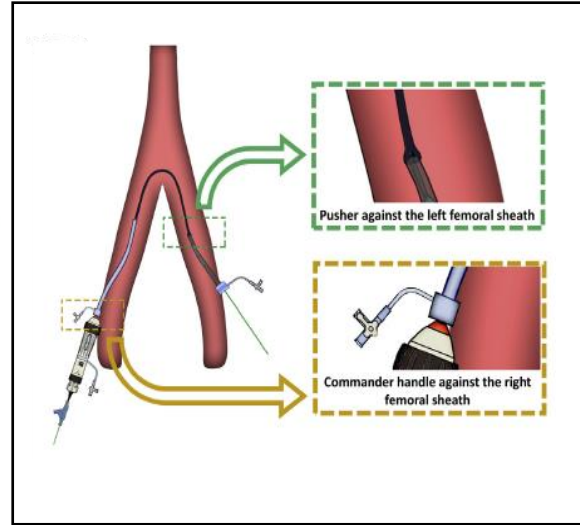
**STEP 2: push the Commander across the aortic bifurcation**

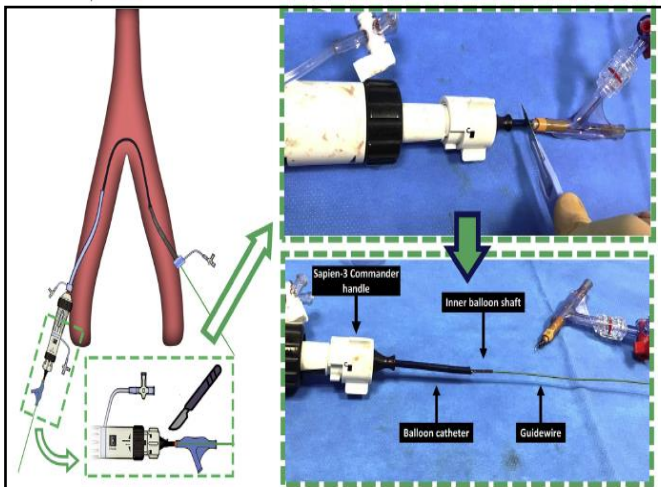
**STEP 3: cut the commander at the proximal end: this will separate the pusher/balloon catheter system from the inner balloon shaft**

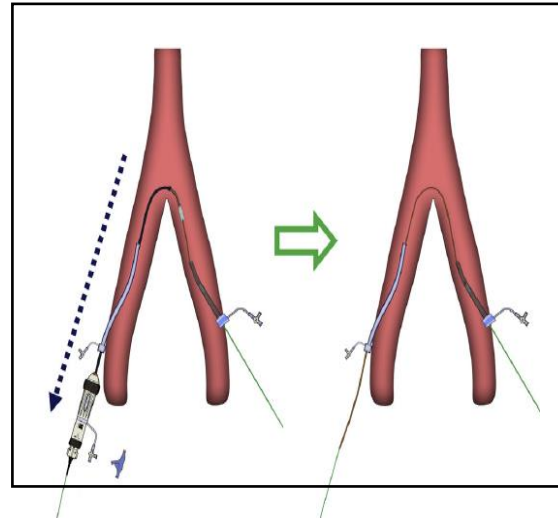
**STEP 4: remove the Commander pulling it from the right femoral sheath. After this maneuver only the inner balloon shaft with the distal part of the balloon will remain in place**

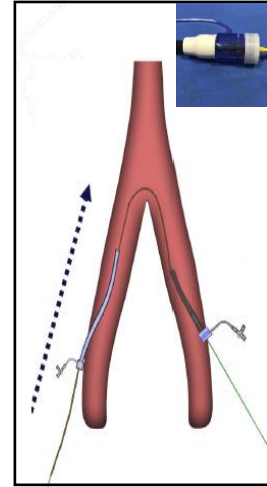
**STEP 5: push the inner balloon shaft to externalize it through the left femoral sheath**

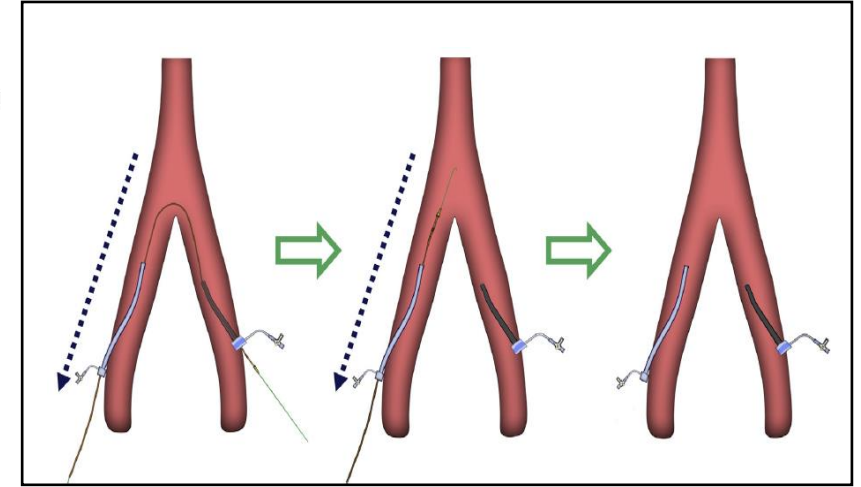
**STEP 6: remove the inner balloon shaft with the distal part of the balloon by pulling it with the wire from the right femoral sheath**
